UNDERWATER BRIDGE INSPECTION REPORT

STRUCTURE NO. 2366

MISSISSIPPI RIVER

JOB NO. 5221 (CEI 34)

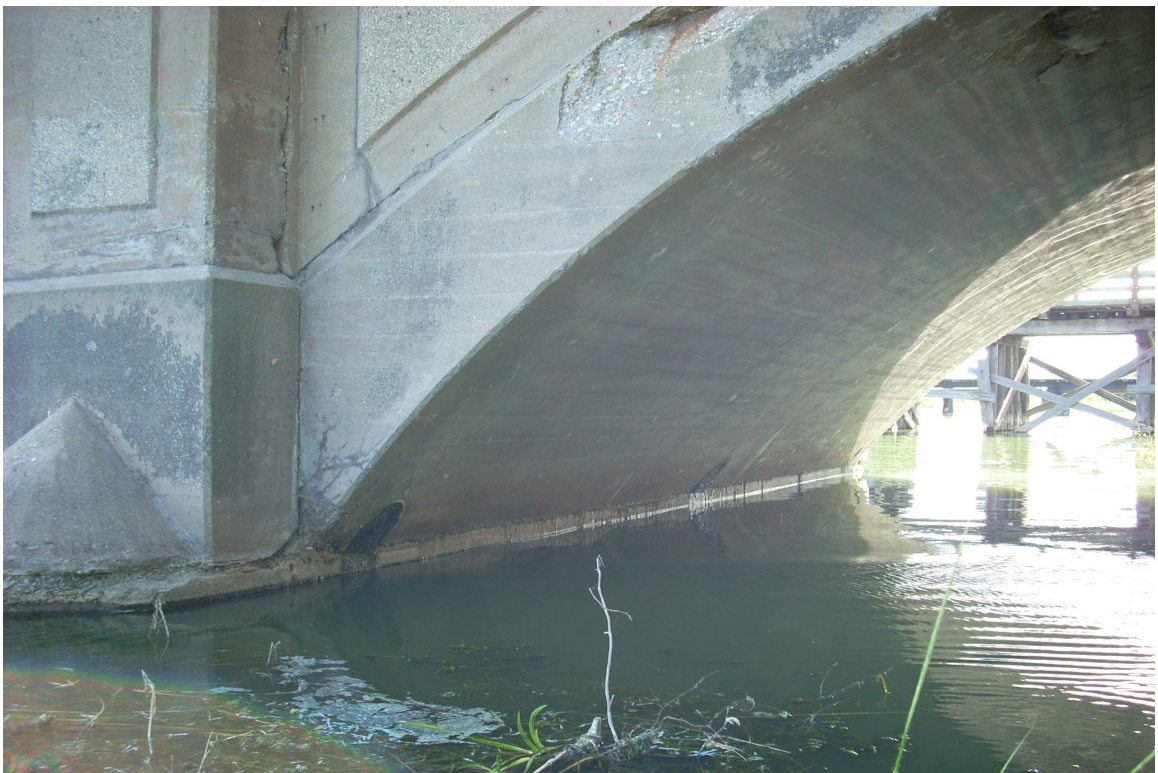
- (A) Moderate to heavy scaling was present around much of the perimeter of the piers in a horizontal band typically located between 3.5 feet above and 1 foot below the waterline, with typical penetrations of 2 to 3 inches and maximum penetrations of 6 to 12 inches. Corroded steel reinforcing with minor section losses was randomly exposed in the scaling.

Photograph 2. View of Pier 1, Looking Southeast.

- (A) Although the present extent of pier deterioration has yet to significantly compromise structural integrity, the deterioration has and will continue to progress. If long term serviceability is desired for the structure, consideration should be given to removing all unsound concrete and restoring concrete surfaces by patching and recasting with a concrete mix designed for high durability and low permeability.
- (B) Reinspect the submerged substructure units at the normal maximum recommended (NBIS) interval of five (5) years.

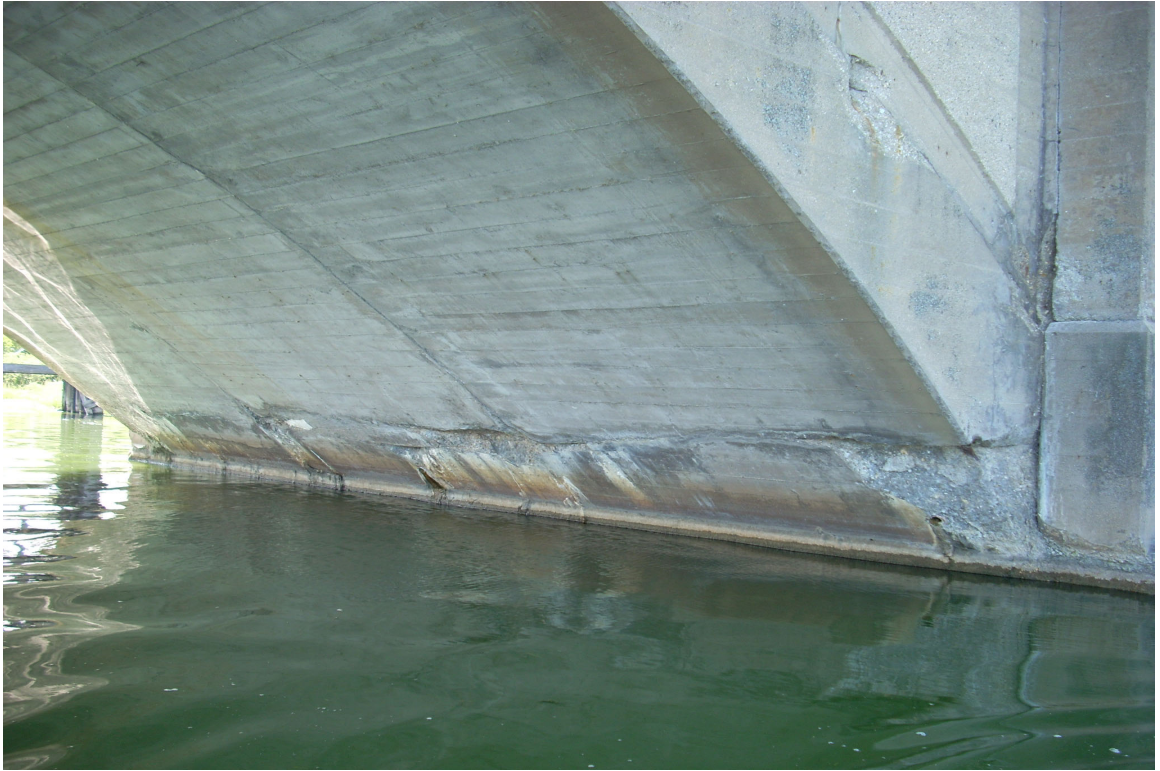
Photograph 3. View of Pier 1, Looking Southwest.

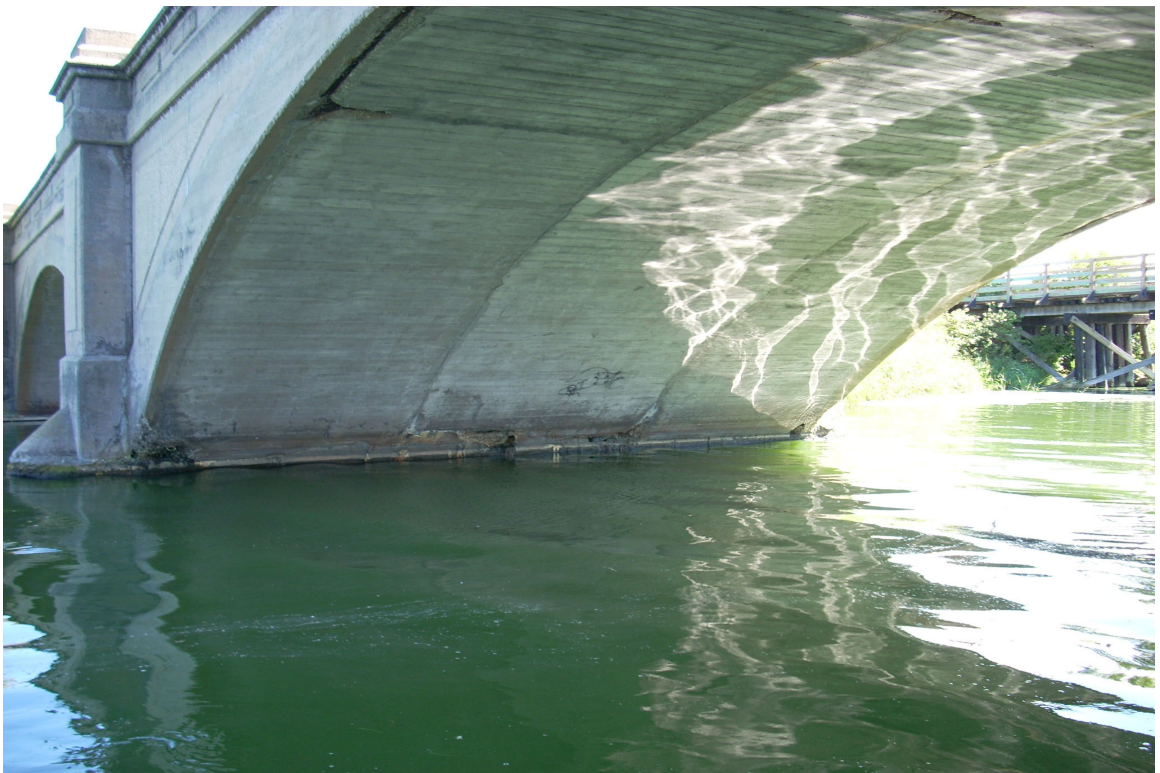
Photograph 4. View of Pier 2, Looking Southeast.

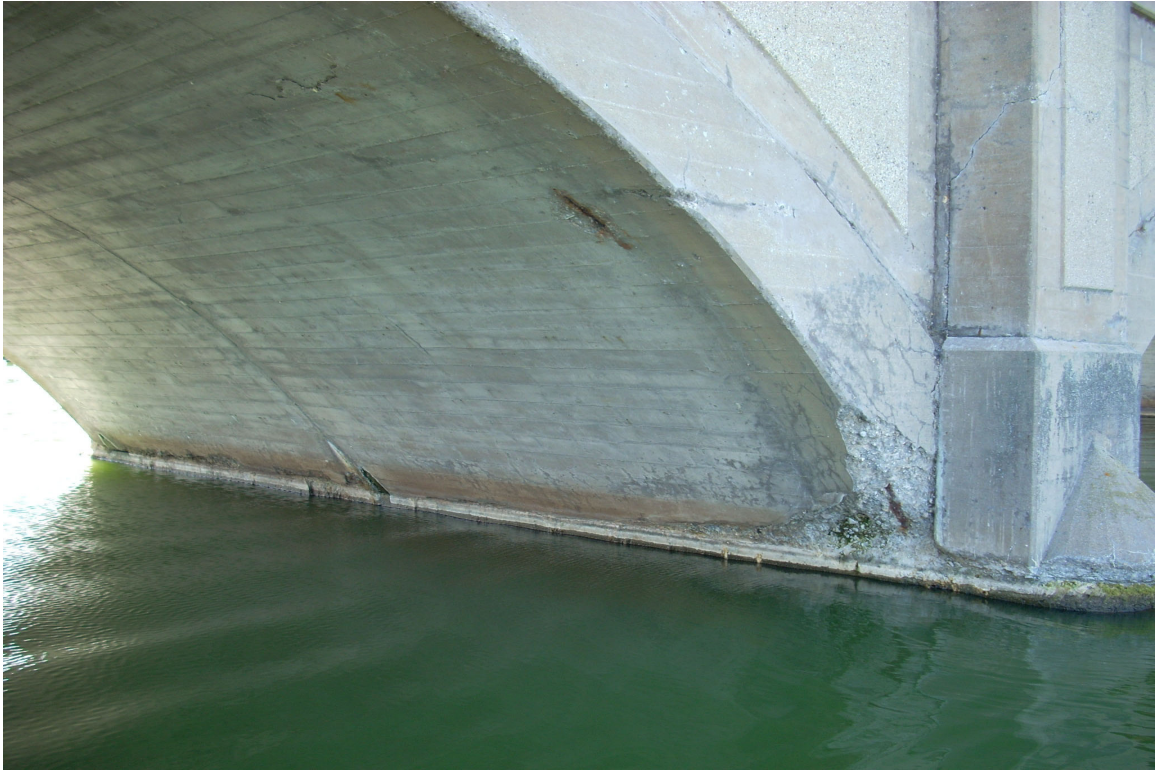
Photograph 5. View of Pier 2, Looking Southwest.

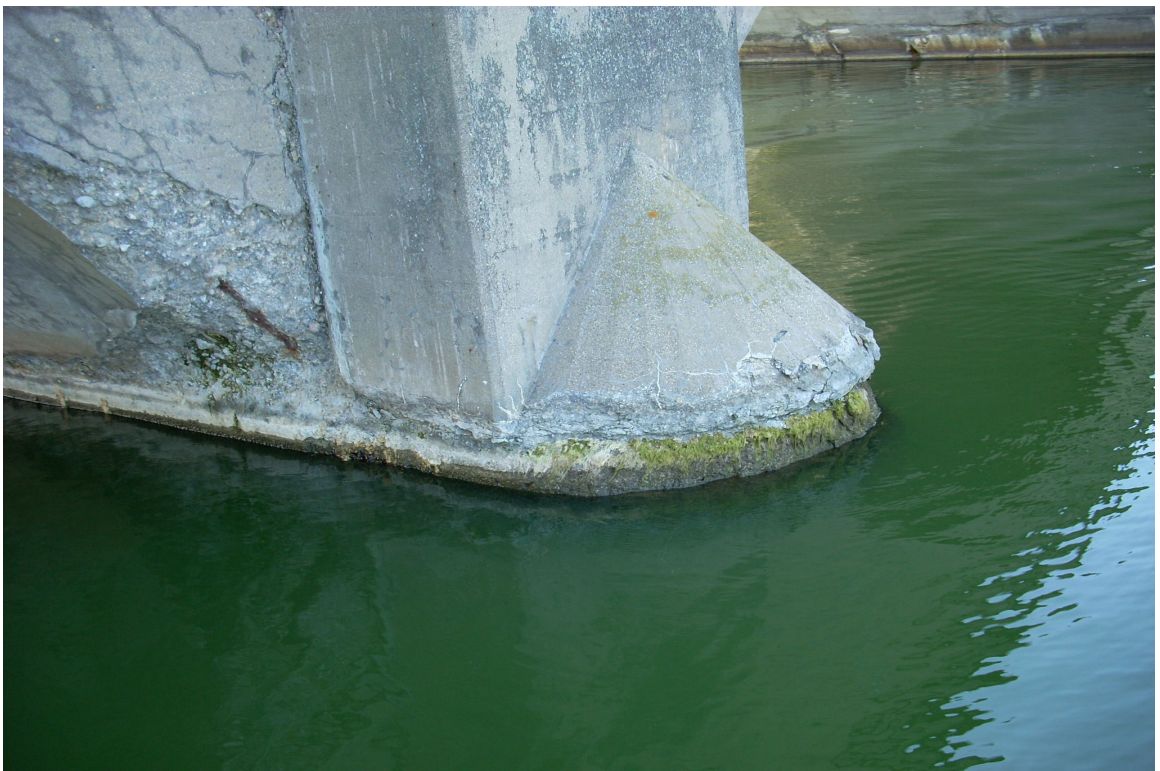
Photograph 6. View of the Downstream Nose of Pier 2, Looking West.

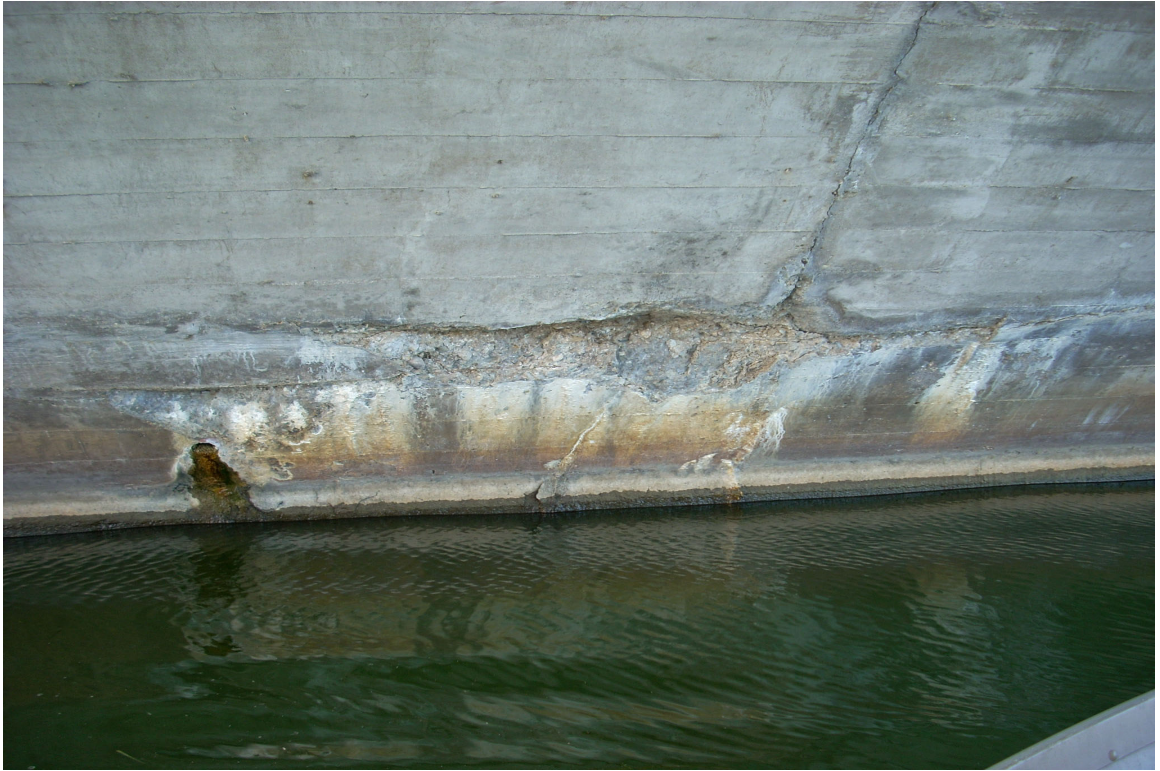
Photograph 8. View of Spall at West face of Pier 1, Looking West.

- Area of section loss was observed at midpoint on west face of Pier 1, 1 foot long by 2 inch high, 2 feet below the waterline with 2 inches of maximum penetration.

Monitor the extent of the section loss during future inspections, and if found to be significantly progressing, repairs may be warranted to ensure long term serviceability at that time.

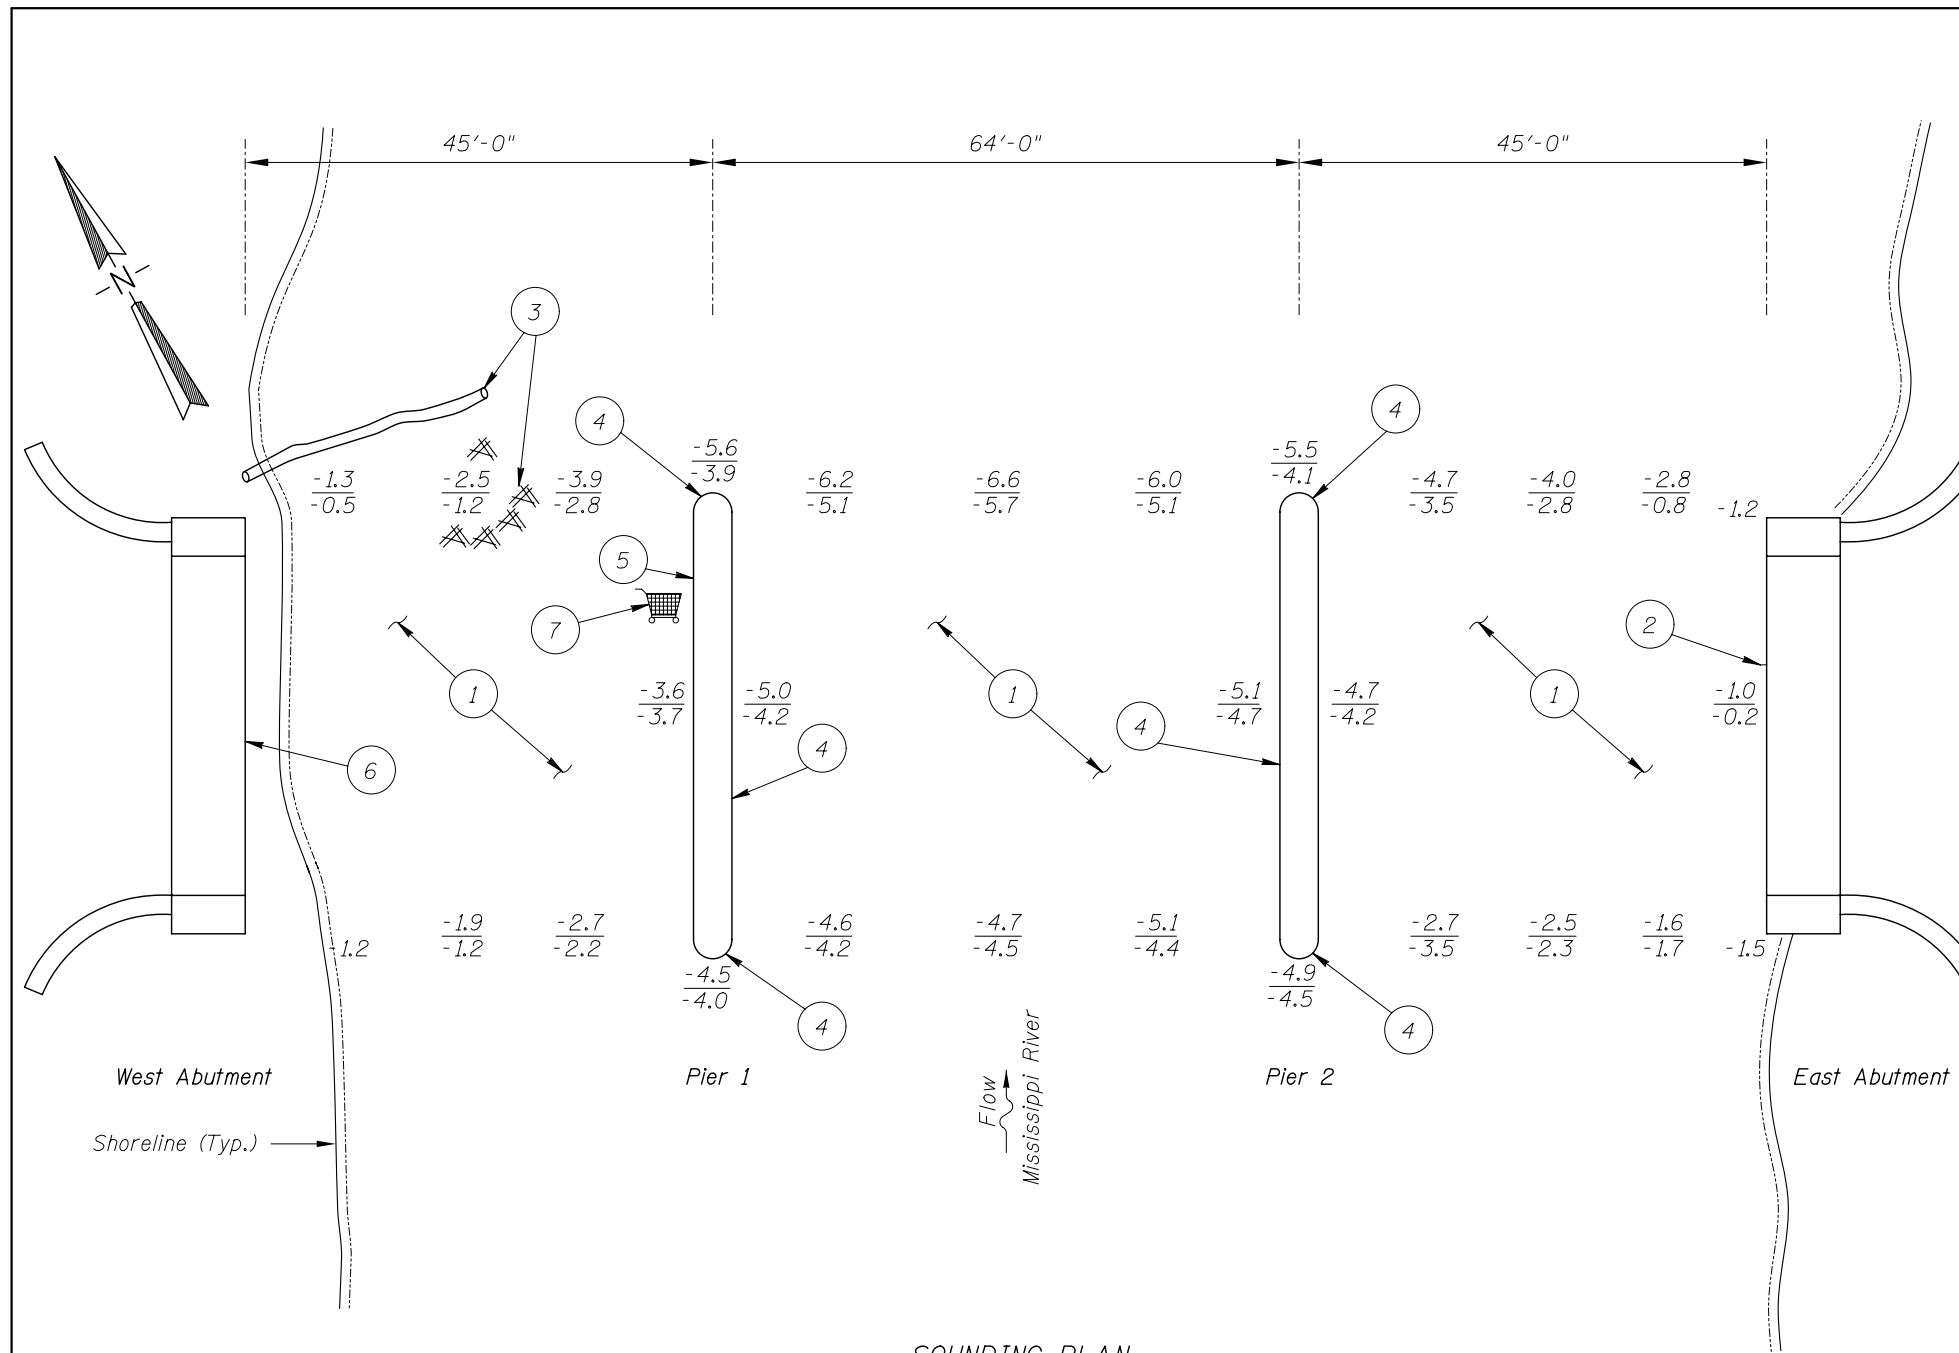
SOUNDING PLAN

- INSPECTION NOTES:
- The channel bottom material consisted of firm sandy gravel and cobbles with 2 to 3 inches of probe rod penetration.
 - Below the waterline concrete of the east abutment was smooth and sound with a light layer of aquatic growth and no defects of structural significance observed.

- A moderated accumulation of timber debris, including a 20-foot-long by 1-foot-diameter log, was observed extending from the West Abutment to the downstream end of Pier 1.

- Band of scaling, impending spalling, spalling with exposed and corroded rebar, and section loss around both piers typically located between 1 foot below and 3.5 feet above the waterline, with typical penetrations of 2 to 3 inches and maximum penetrations of 6 to 12 inches. The heaviest deterioration was located at the upstream pier noses and along the east side of Pier 1 and the west side of Pier 2.

- Random hairline to 1/16-inch-wide map cracking with light amounts of efflorescence were observed on the west abutment from the channel bottom to 3 feet above the channel bottom.

- Shopping cart was observed on the channel bottom at the downstream quarter point adjacent to the west face of Pier 1. Other debris was also located randomly between Pier 1 and West Abutment.
